# 1. Introduction and Project Setting

The objectives of this study were to characterize existing lake conditions and to make recommendations to protect and improve the lake environment where feasible.

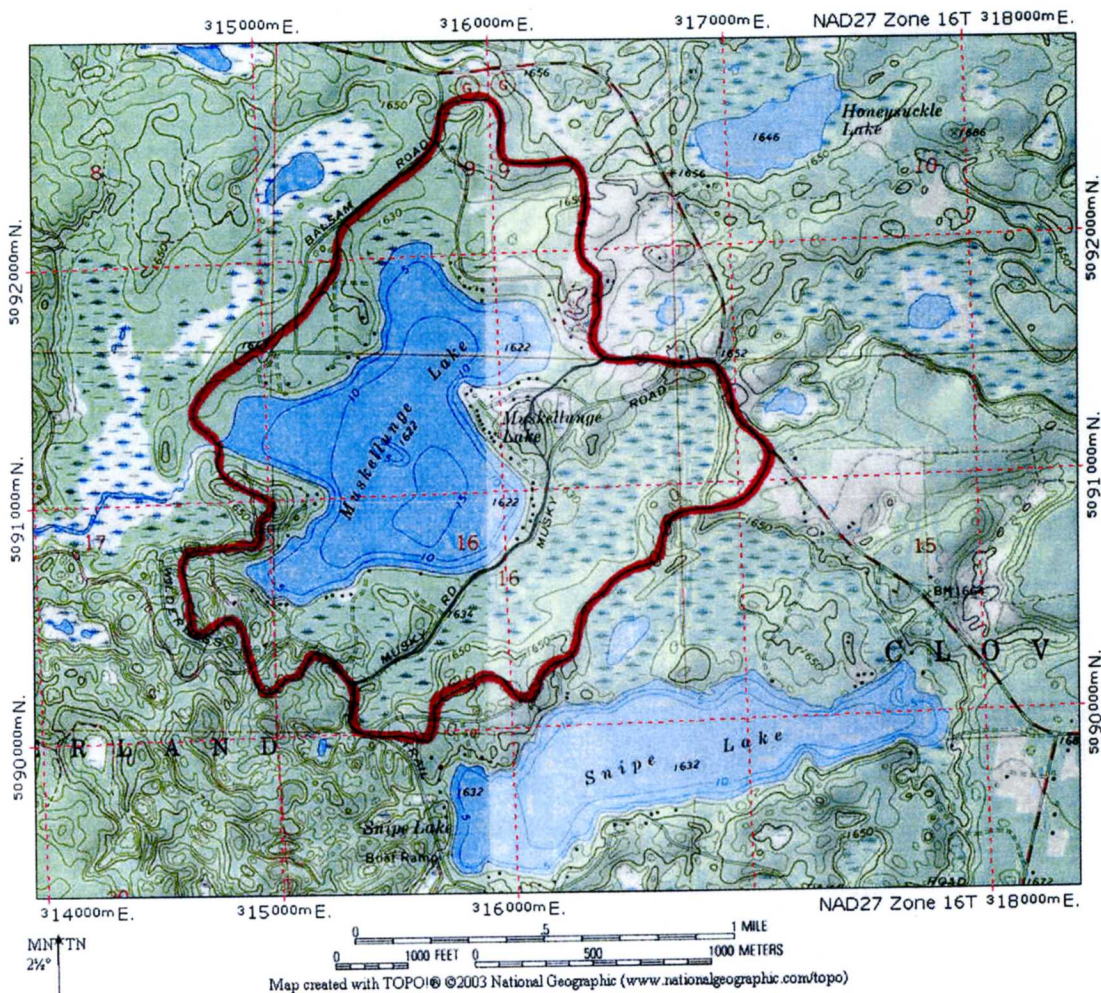
Figure 4. The direct drainage watershed area for Muskellunge Lake is outlined in red (source: Robertson et al 2003).

The direct drainage area to Muskellunge Lake is 550 acres (from a report Robertson et al 2003) and the delineation is shown in Figure 4. The watershed to lake ratio of Muskellunge Lake is 2 to 1. Typically a small watershed like this should yield low phosphorus loads to the lake resulting in good water clarity. However, the overall watershed includes more area than just the direct drainage area.

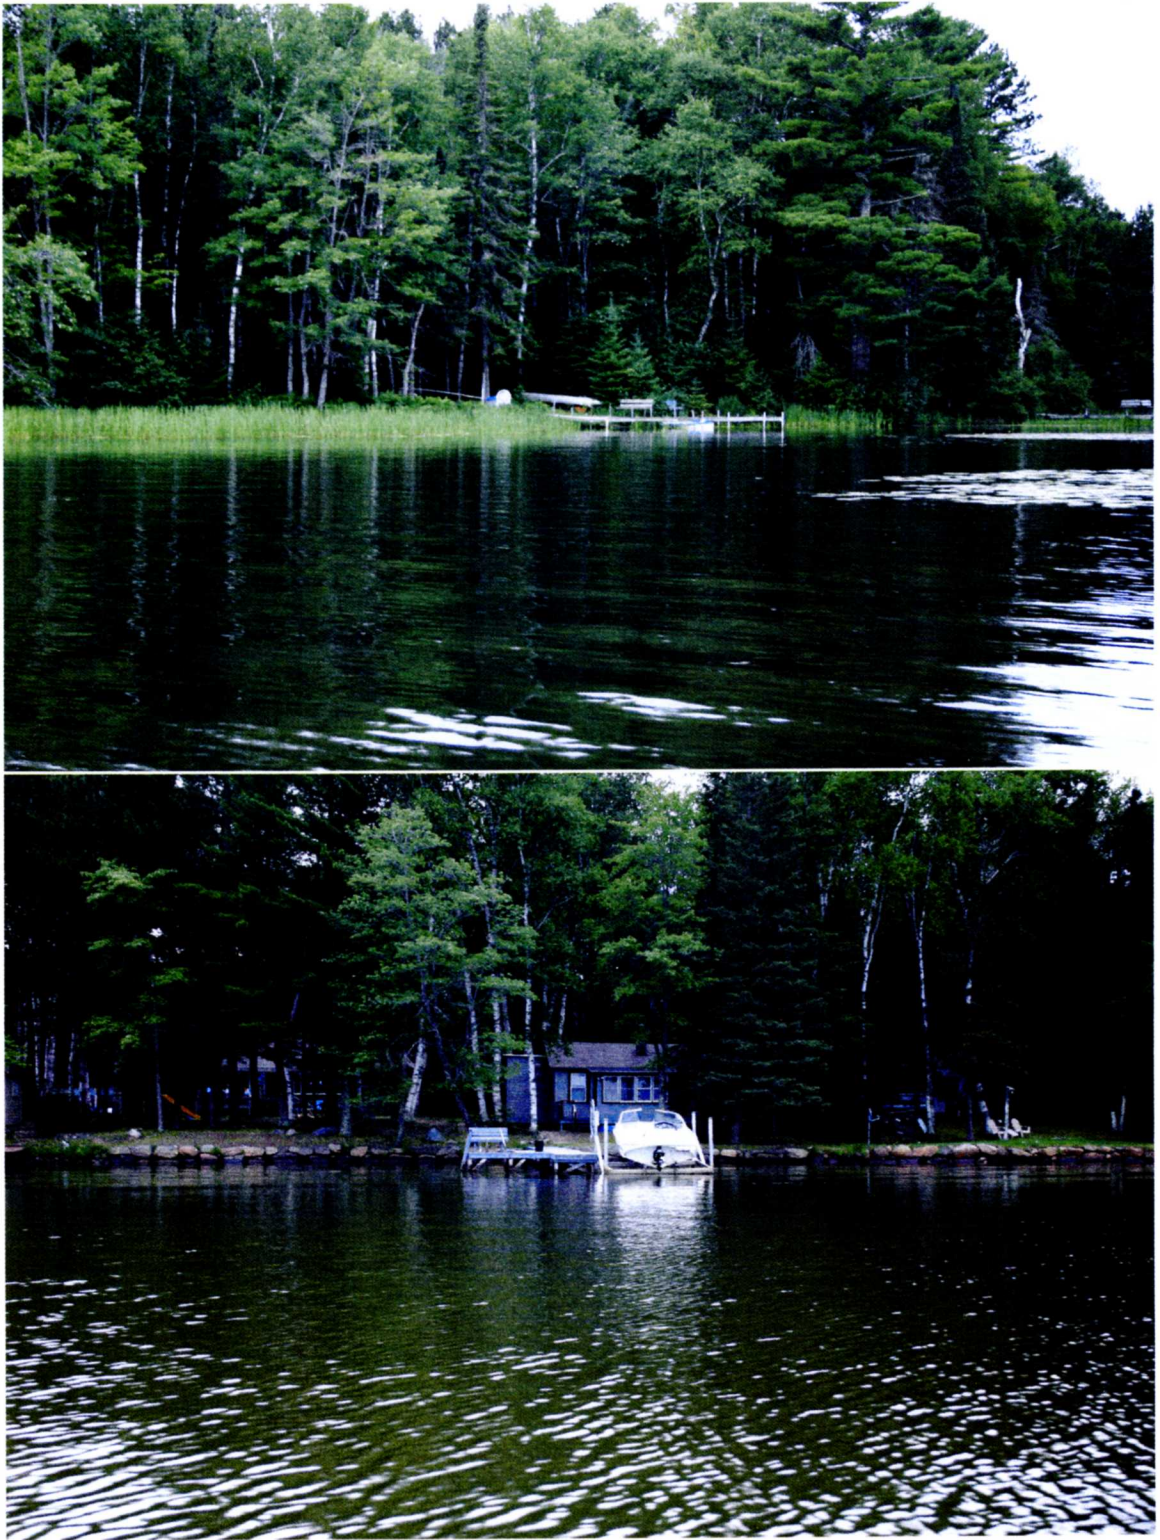
**Figure 6. [top] This parcel would rate as having a shoreline with a buffer greater than 50% of the lot width and an understory with greater than 50% natural cover. [bottom] This parcel would not qualify as having a natural shoreline buffer greater than 50% of the lot width. Also understory in the upland area would be rated as having less than 50% natural cover.**

For analysis, each photograph was evaluated by Blue Water Science staff for shoreline and upland conditions. Our criteria for natural conditions were the presence of 50% native vegetation in the understory and at least 50% natural vegetation along the shoreline in a strip at least 15 feet deep. Although the shoreline recommendations for new development is a 35-foot deep buffer, a 15-foot deep buffer is about the minimum needed to achieve some degree of runoff water quality treatment. We evaluated shorelines and uplands at the 75% natural level as well (Figure 6 illustrates the methodology).

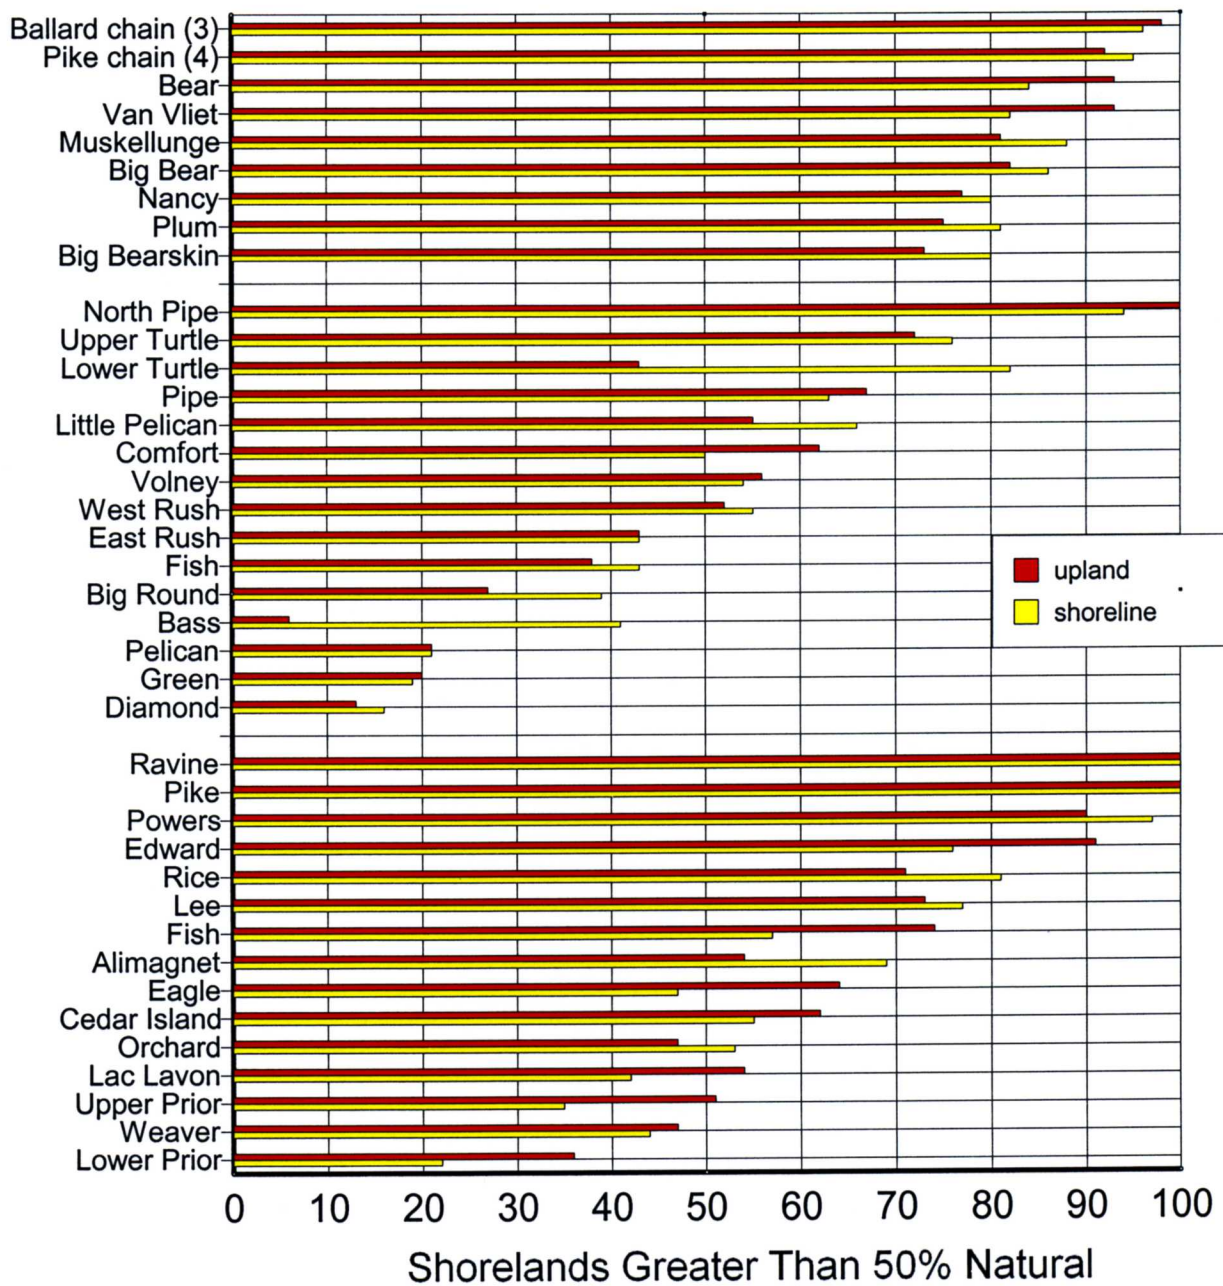
Figure 7. A summary of shoreland inventory results for lakes using an evaluation based on shoreland photographs. For each lake the percentage of shoreline and upland conditions with greater than 50% natural conditions is shown. The first tier of lakes are located in northern Wisconsin. The lower tier of lakes are in the Twin City Metropolitan area and are considered urban lakes. Although several lakes are “urban” lakes most of the shoreland is owned by the city and there is a high percentage of natural conditions. The middle tier of lakes are about an hour or two drive from the Twin Cities, and are not considered to be urban lakes, but are referred to as “country” lakes.

A comparison of Muskellunge Lake conditions to other lakes in Minnesota and Wisconsin is shown in Table 4 and in Figure 7.

Muskellunge Lake is in the northern Wisconsin tier of lakes. It’s natural shoreland conditions are about average compared to the other northern Wisconsin lakes.

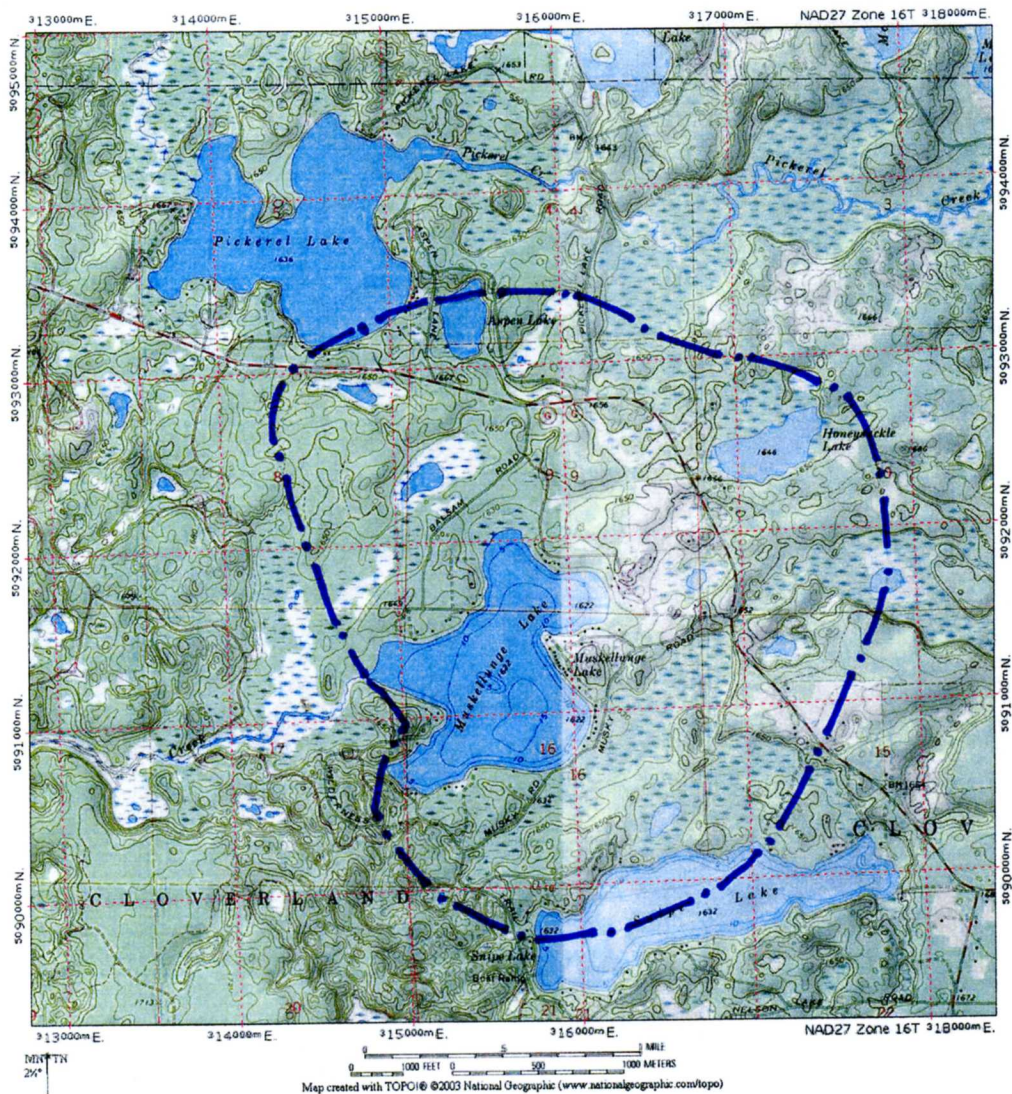
Figure 8. Muskellunge Lake ground watershed based on USGS estimates.

Muskellunge Lake may be receiving groundwater inflows about 2,000 acres (Figure 8). It is not surprising that springs are found in Muskellunge Lake. This was an active glacial area in the past and often leads to subsurface groundwater inflows. The estimated area that contributes groundwater is close to the estimated contributing area shown previously in Figure 5.

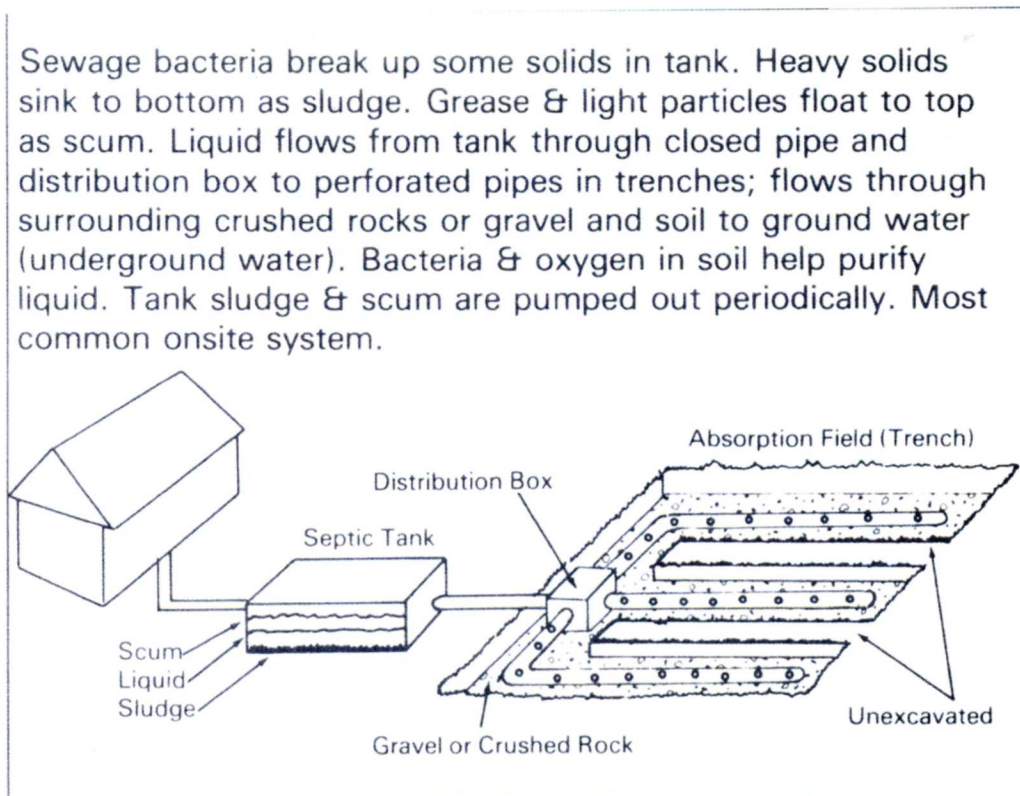
**Figure 9.** Typical onsite wastewater treatment system found in the Muskellunge Lake watershed.

**Onsite Systems Status:** Onsite systems appear to be in mostly good condition based on the surrounding soils which are conducive to good infiltration, and the setback of the cabins and homes. A conventional onsite system is shown in Figure 9. With proper maintenance (such as employing a regular pumping schedule) onsite systems are an excellent wastewater treatment option. The challenge is to maintain systems in good working condition.
