Prepared by: EOR

For the: **Muskellunge Lake Association**

2023 Muskellunge Lake EWM Control Grant

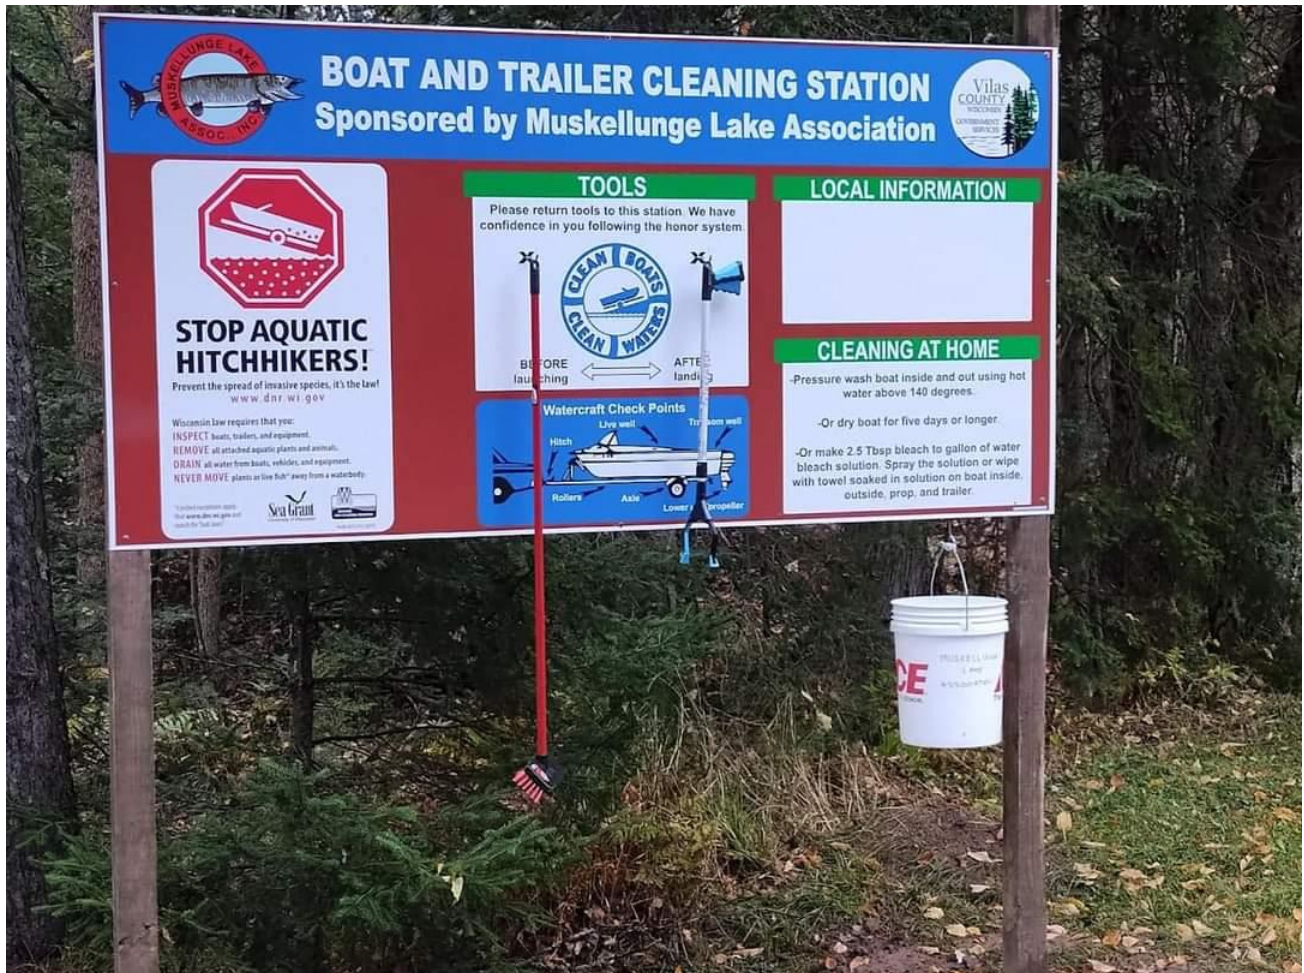
Figure 5. Muskellunge Lake Boat Landing

The MLA has shifted its current and future management efforts towards prevention techniques. On 10/15/2023, the MLA secured approval from Vilas County to add new signage at the public landing along with tools to help prevent the introduction of all aquatic invasive species, to include EWM (Figure 5).

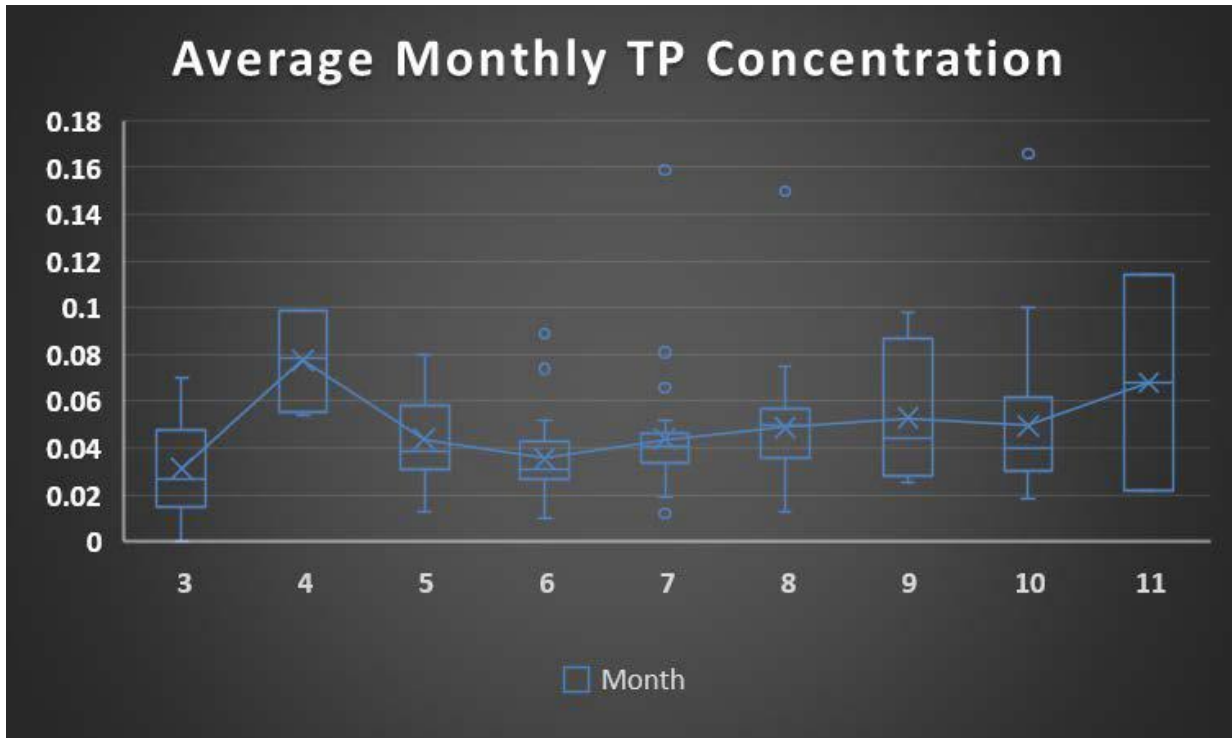
Figure 3. Average Monthly Total Phosphorus (TP) Concentrations

Figure 3, derived from the [2020 Muskellunge Lake Management Plan](#), shows that the average monthly Total Phosphorus concentration is highest during the month of April, a month that often coincides with spring turnover. In 2021, this pattern continued, a water quality sample collected on April 5, 2021, resulted in an observed in-lake Total Phosphorus concentration of 94 µg/L, the highest observation recorded in 2021. The first water quality sample collected in 2022 was on May 4, 2022. No samples were collected in April due to a later than normal ice-out. Like previous years, the first sample collected in 2022 had a slightly higher Total Phosphorus concentration at 43.9 µg/L. Observed Total Phosphorus concentrations in samples collected from June-August ranged from 36.3 to 42.7 µg/L. A review of water quality data and dissolved oxygen profile data continues to provide evidence to suggest that there are periods of time in which the Muskellunge Lake hypolimnion goes anoxic during the winter. As spring arrives, the lake experiences a spring turnover. Phosphorus rich water, contained in the bottom portions of the lake that are going anoxic mixes with surface waters, resulting in elevated in-lake phosphorus concentrations shortly after ice-off. Overall, water quality in Muskellunge Lake remains stable with no significant trend (Figure 4).

- b. Water quality data collected pre/post treatment suggested in-lake Total Phosphorus concentrations remained at or below the state standard of 40 µg/L. Total Phosphorus concentrations observed during spring turnover provide additional validation that a portion of the lake is going hypoxic during the winter, leading to the release of phosphorus from the sediment-water interface.
